# Building Survey

36 HAVELOCK ROAD  
LONDON  
SE9 2DS

DB-SE42DQ-36

11 June 2026

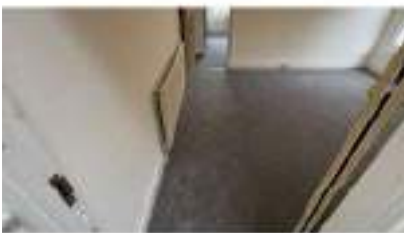
Bedroom 4

- The heating system in the room appeared adequate at the time of inspection, but no testing was carried out
- Staining is visible on the chimney breast, likely indicating moisture ingress from the chimney structure above or salt contamination. Further investigation is required to identify the source of high moisture reading and associated concealed damage

The chimney breast in bedroom four should be investigated by a damp specialist and a chimney engineer to establish the source of moisture and to provide ventilation to the capped flue, followed by replastering with a salt-resistant plaster. The damp-proof course bridging at the front porch should be addressed by removing or modifying the render to expose the damp-proof course, and the localised weathered pointing on the rear elevation should be raked out and replaced with a lime-based mortar. The rear bay downpipe should be extended into a gully or surface water drain.

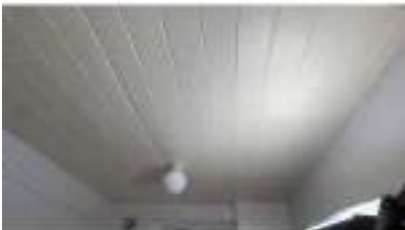
Bathroom

- The metal bath has visible wear to the enamel, consistent with its age. The ceramic wash basin is also aged, and both fittings should be budgeted for replacement in the medium term

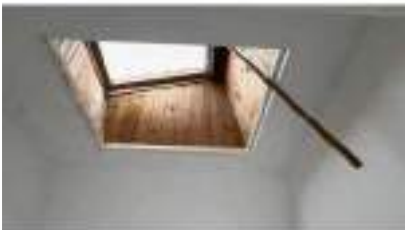
Hallway

- Elevated moisture levels recorded in the front living room may be linked to a defect affecting the hallway area. Further investigation is required to trace the source

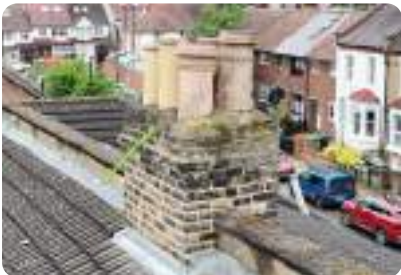
**Photo 4**  
Rear chimney stack on the main roof but some wear on the flaunching.

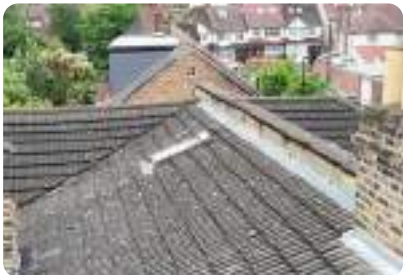
**Photo 5**  
Main roof concrete interlocking tiles generally appear to be in an adequate condition but spalling render on valleys requires repair. Some mild deflection identified on the rear roof junction

The spalling render on the parapets will require repair, as parapets are exposed to the weather on both sides and are vulnerable to water ingress if the render or copings are defective.

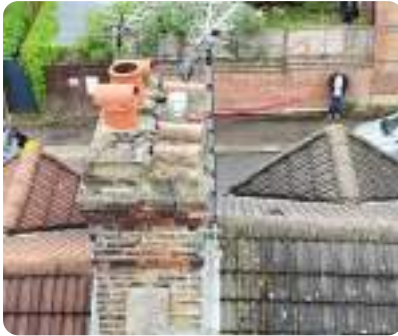
**Photo 7**

View of the chimney stack from the roof; visible deterioration of the mortar and missing pots at the top of the stack.

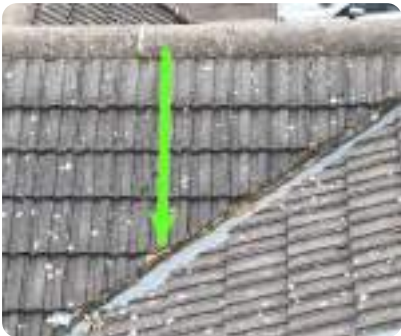
The roof void inspection revealed containers positioned to capture water, suggesting a history of intermittent leaks in the area of the rear valley, and some high moisture readings were recorded on the rear valley rafter within the roof void, which may be attributable to condensation rather than a roof covering defect. A small tear was noted in the roofing membrane, which appeared to have been made deliberately to aid ventilation.

**Photo 13**  
Spalling render to the valley rafter.  
Possible cause of leak into the receptacle  
in roof space below.

The roof valley area where the history of water capture and elevated moisture readings were recorded should be inspected more closely from a ladder or scaffold during dry weather to assess the condition of the valley gutter, leadwork, and roof membrane. The concealed condition of the lintel bearings and any internal steel or timber supports behind the masonry window heads could not be verified, and while no external symptoms of deterioration were identified, it would be prudent to have these checked if any future window replacement or renovation work is undertaken.

In the short term, within the first year, you should arrange for a specialist roofing contractor to inspect the main roof, particularly the rear valley area and the lead flashings at the parapet abutments, and carry out any necessary repairs.

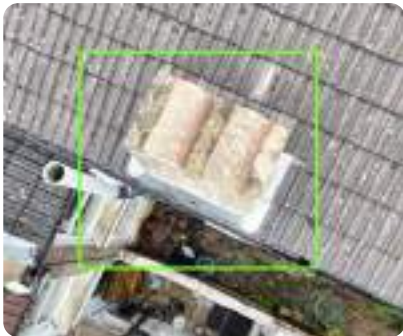
The salt contamination and high moisture readings in bedroom four, where the chimney breast showed staining and elevated moisture meter readings reaching 60 to 70 percent wood moisture equivalent, are likely linked to a capped and unventilated flue, and without adequate through-ventilation, residual moisture and hygroscopic salts within the flue can migrate into the adjoining plaster, causing staining and dampness even in the absence of an active leak.

**Photo 15**  
In the room below this chimney, there is  
salt contamination on the chimney breast.

The high moisture readings and salt contamination on the chimney breast in bedroom four warrant a more detailed investigation to confirm the source of moisture and the condition of the flue, which may involve a CCTV survey of the flue or opening up the plaster to inspect the brickwork and any hidden defects.

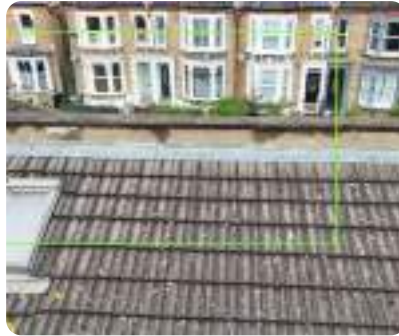
**Photo 20**

Cracks to the render on the parapet wall

The stiff mechanisms on the kitchen tilt-and-turn windows should be attended to by a specialist to prevent further damage and ensure smooth operation. The spalling render on the parapets should be repaired promptly to prevent water ingress, and the spalling render on the parapets should be repaired promptly to prevent water ingress. The parapet repair should be carried out by a competent contractor, and the render should be replaced with a suitable material that allows the brickwork to breathe.

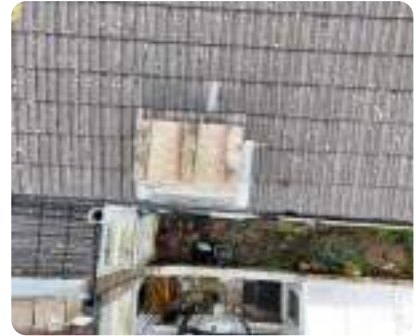
**Photo 21**

Chimney stack on the main roof; there is significant debris accumulation on the stack's surface and surrounding area.

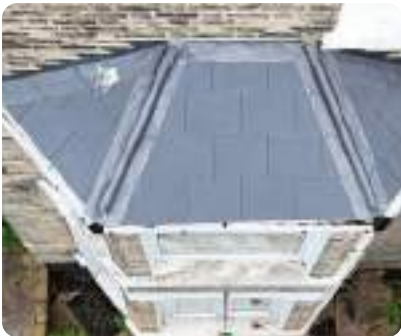
**Photo 31**  
Roof covering over the bay window; the flashing appears to have damage with potential water ingress at the join.

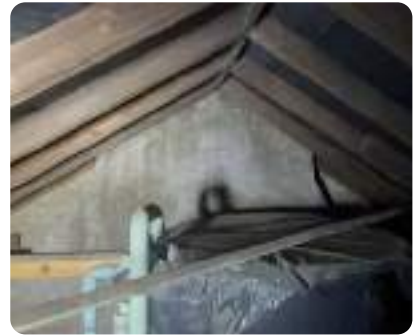
**Photo 97**  
Roof void showing timber rafters and water-stained wall; evidence of possible dampness indicated by discoloration on the wall.

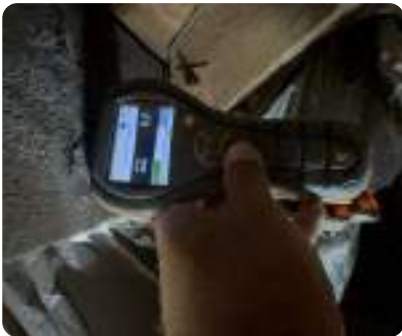
**Photo 112**  
Roof void showing high moisture reading of 9.7%, indicating potential damp issues.

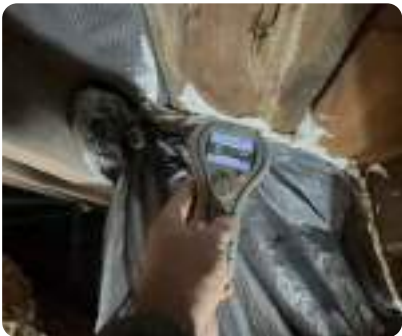
**Photo 114**  
Roof void with moisture meter readings indicating 8.4% moisture content; evidence of possible dampness present.

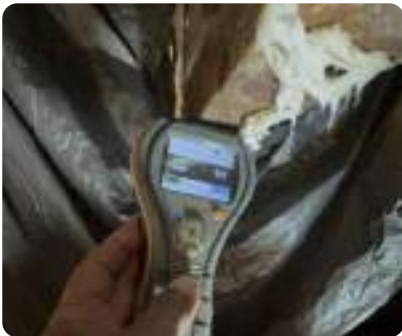
**Photo 115**  
Roof void showing moisture meter reading of 9.5%, indicating potential moisture presence.

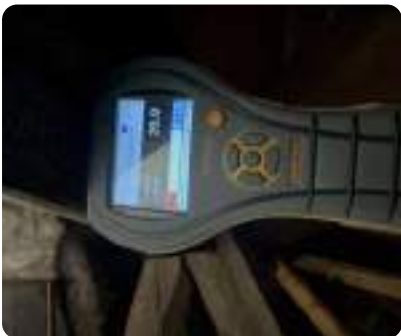
**Photo 116**  
High Moisture Readings and Locations - Loft Valley rafter.
