# Building Survey

36 HAVELOCK ROAD  
LONDON  
SE9 2DS

DB-SE42DQ-36

11 June 2026

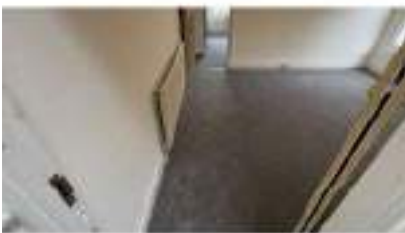
Bedroom 4

- The heating system in the room appeared adequate at the time of inspection, but no testing was carried out
- Staining is visible on the chimney breast, likely indicating moisture ingress from the chimney structure above or salt contamination. Further investigation is required to identify the source of high moisture reading and associated concealed damage

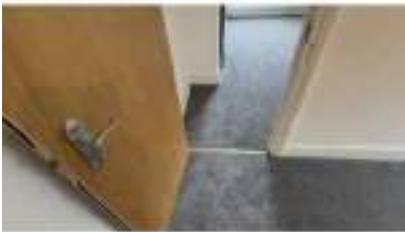
Bedroom 5

- A sink unit is fitted within the room; its plumbing connections were not tested and should be checked for leaks and adequate fall

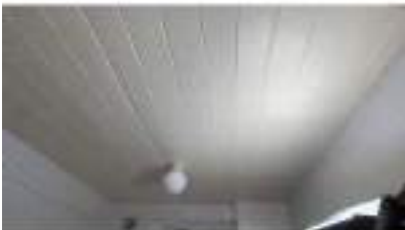
Bathroom

- The metal bath has visible wear to the enamel, consistent with its age. The ceramic wash basin is also aged, and both fittings should be budgeted for replacement in the medium term

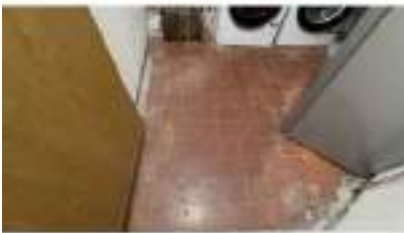
Utility Room

- The stone step at the utility room entrance is old but appears to be in adequate condition
- The gully appeared to be in adequate condition but would benefit from cleaning and a cover to prevent debris entering the drain

- The soil stack at the rear of the property is a mix of cast iron to the upper section and UPVC to the base, suggesting past drainage repairs; your Legal Adviser should check the property information for any evidence of underpinning or a claim for defective drainage-related subsidence

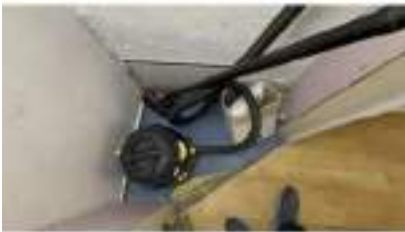
Hallway

- A breach in the fire boarding was noted at the staircase, which should be repaired to restore the integrity of the fire separation

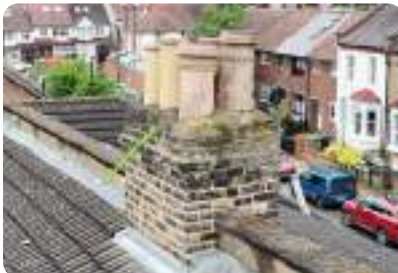
**Photo 4**  
Rear chimney stack on the main roof but some wear on the flaunching.

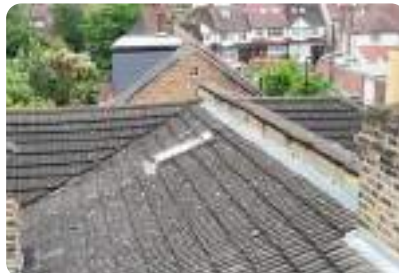
**Photo 5**  
Main roof concrete interlocking tiles generally appear to be in an adequate condition but spalling render on valleys requires repair. Some mild deflection identified on the rear roof junction

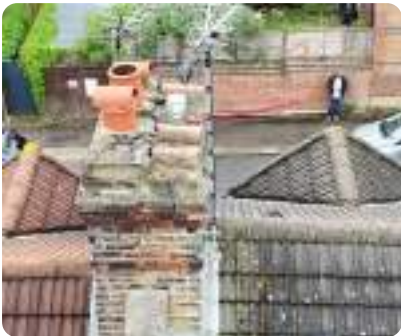
**Photo 7**  
View of the chimney stack from the roof; visible deterioration of the mortar and missing pots at the top of the stack.

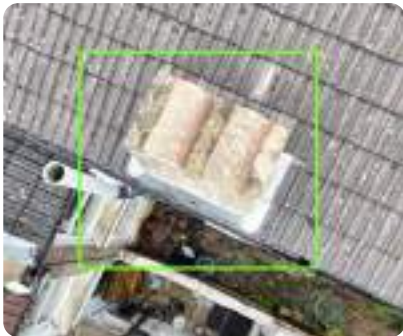
The salt contamination and high moisture readings in bedroom four, where the chimney breast showed staining and elevated moisture meter readings reaching 60 to 70 percent wood moisture equivalent, are likely linked to a capped and unventilated flue, and without adequate through-ventilation, residual moisture and hygroscopic salts within the flue can migrate into the adjoining plaster, causing staining and dampness even in the absence of an active leak.

**Photo 15**  
In the room below this chimney, there is  
salt contamination on the chimney breast.

The high moisture readings and salt contamination on the chimney breast in bedroom four warrant a more detailed investigation to confirm the source of moisture and the condition of the flue, which may involve a CCTV survey of the flue or opening up the plaster to inspect the brickwork and any hidden defects.

The chimney breast in bedroom four should be investigated by a damp specialist and a chimney engineer to establish the source of moisture and to provide ventilation to the capped flue, followed by replastering with a salt-resistant plaster. The damp-proof course bridging at the front porch should be addressed by removing or modifying the render to expose the damp-proof course, and the localised weathered pointing on the rear elevation should be raked out and replaced with a lime-based mortar. The rear bay downpipe should be extended into a gully or surface water drain.

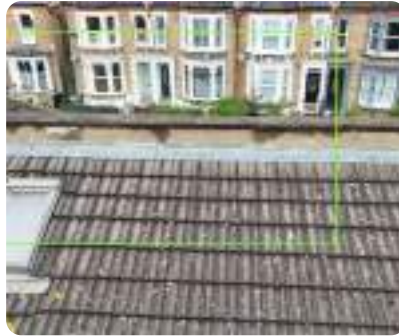
**Photo 20**

The spalling render on the parapets will require repair, as parapets are exposed to the weather on both sides and are vulnerable to water ingress if the render or copings are defective.

Cracks to the render on the parapet wall

The stiff mechanisms on the kitchen tilt-and-turn windows should be attended to by a specialist to prevent further damage and ensure smooth operation. The spalling render on the parapets should be repaired promptly to prevent water ingress, and the spalling render on the parapets should be repaired promptly to prevent water ingress. The parapet repair should be carried out by a competent contractor, and the render should be replaced with a suitable material that allows the brickwork to breathe.

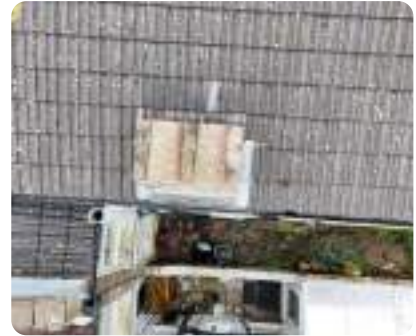
**Photo 21**

Chimney stack on the main roof; there is significant debris accumulation on the stack's surface and surrounding area.

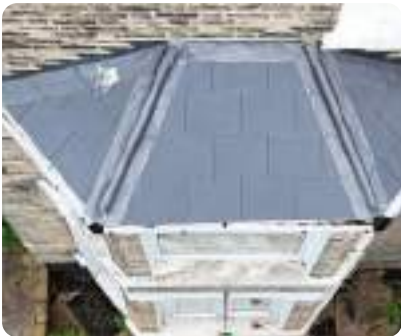
**Photo 31**  
Roof covering over the bay window; the flashing appears to have damage with potential water ingress at the join.

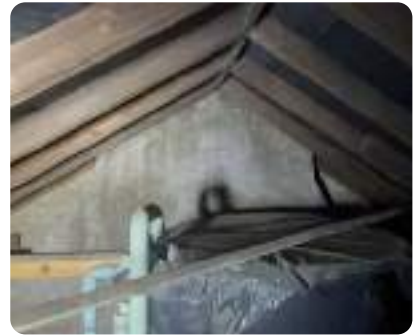
**Photo 97**  
Roof void showing timber rafters and water-stained wall; evidence of possible dampness indicated by discoloration on the wall.

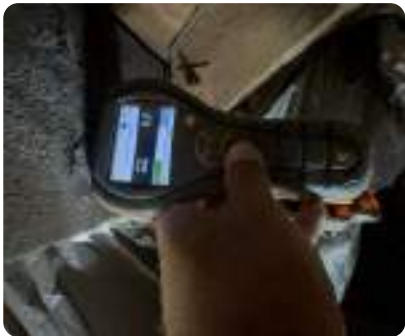
**Photo 112**  
Roof void showing high moisture reading of 9.7%, indicating potential damp issues.

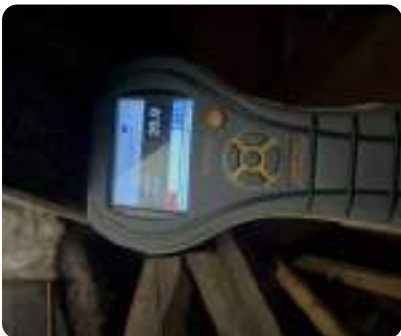
The roof void inspection revealed containers positioned to capture water, suggesting a history of intermittent leaks in the area of the rear valley, and some high moisture readings were recorded on the rear valley rafter within the roof void, which may be attributable to condensation rather than a roof covering defect. A small tear was noted in the roofing membrane, which appeared to have been made deliberately to aid ventilation.

**Photo 116**  
High Moisture Readings and Locations - Loft Valley rafter.

The roof valley area where the history of water capture and elevated moisture readings were recorded should be inspected more closely from a ladder or scaffold during dry weather to assess the condition of the valley gutter, leadwork, and roof membrane. The concealed condition of the lintel bearings and any internal steel or timber supports behind the masonry window heads could not be verified, and while no external symptoms of deterioration were identified, it would be prudent to have these checked if any future window replacement or renovation work is undertaken.
