# Building Survey

36 HAVELOCK ROAD  
LONDON  
SE9 2DS

DB-SE42DQ-36

11 June 2026

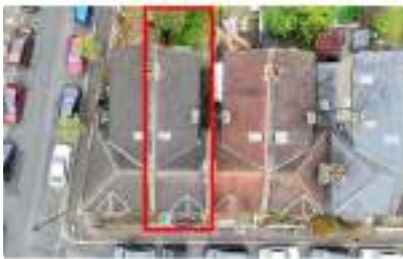
**Photo 2**  
Main roof viewed from above

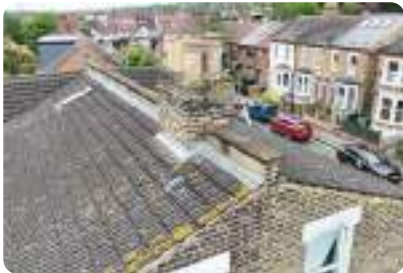
**Photo 3**  
Rear elevation main roof in clay tiles; no visible defects.

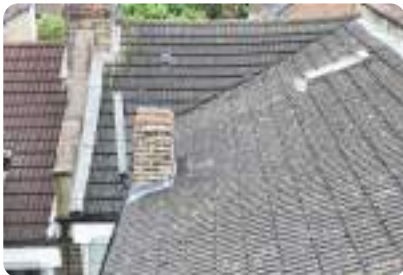
**Photo 6**  
Chimney stack on the main roof; no visible defects.

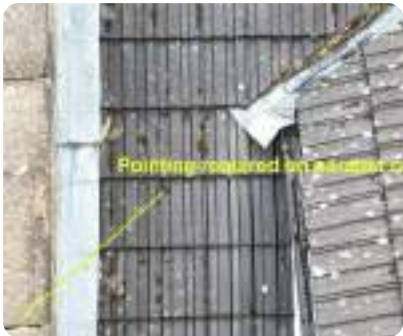
**Photo 14**  
Main roof concrete interlocking tiles  
generally appear to be in an adequate  
condition but spalling render on valleys  
requires repair.

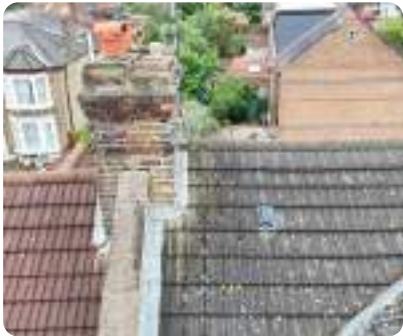
**Photo 17**  
Main roof concrete interlocking tiles  
generally appear to be in an adequate  
condition but spalling render on valleys  
requires repair.

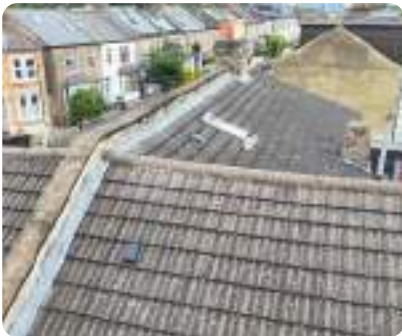
**Photo 27**  
Main roof concrete interlocking tiles generally appear to be in an adequate condition but spalling render on valleys requires repair.

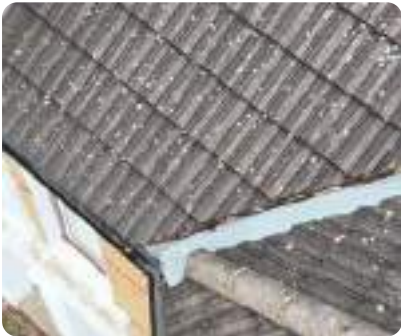
**Photo 28**  
Main roof concrete interlocking tiles generally appear to be in an adequate condition but spalling render on valleys requires repair.

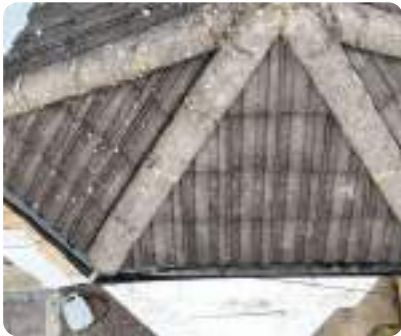
**Photo 29**  
Main roof concrete interlocking tiles generally appear to be in an adequate condition but spalling render on valleys requires repair.

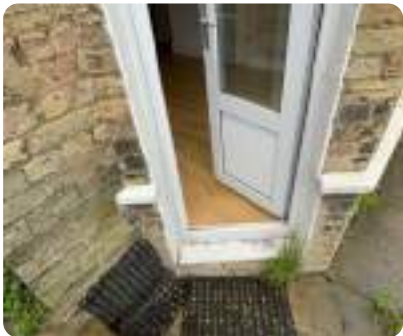
**Photo 72**  
External Walls - This rear bay has been structurally altered with a new door opening.

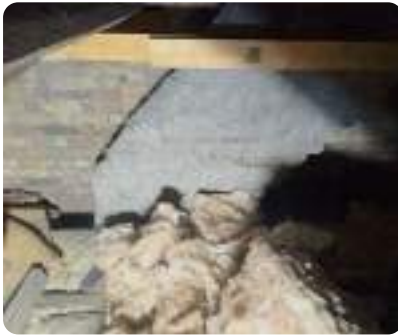
**Photo 95**  
Roof void showing insulation and exposed brickwork; no visible defects.

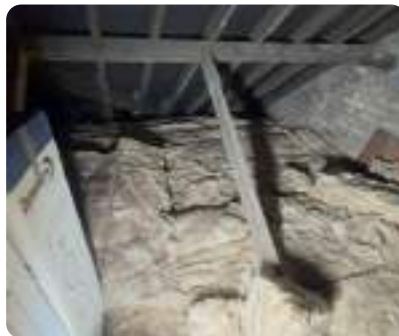
**Photo 99**  
Attic space showing insulation material; no visible defects.

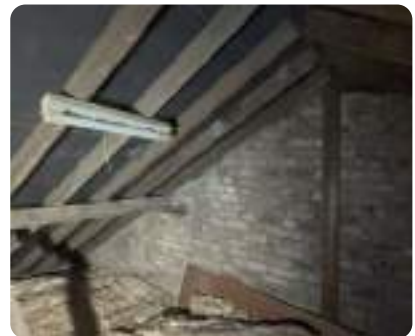
**Photo 100**  
Roof void showing timber framing and insulation; no visible defects.

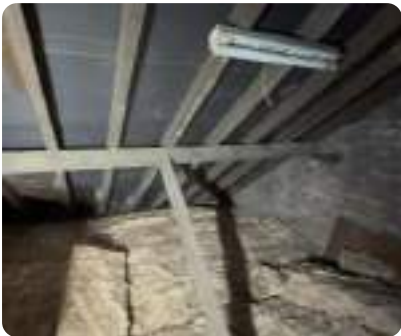
**Photo 101**  
Roof void showing timber rafters; no visible defects.

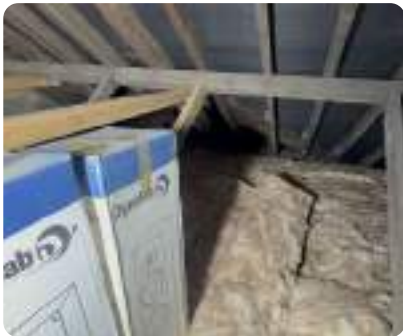
**Photo 103**  
Roof void observed with exposed timber rafters and insulation; no visible defects.

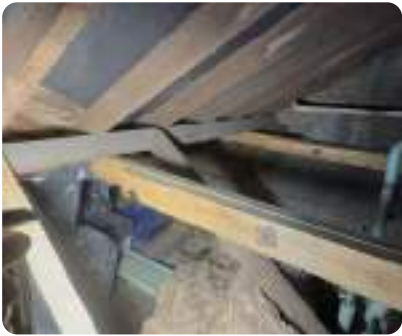
**Photo 105**  
Roof void showing timber framing and insulation materials; no visible defects.

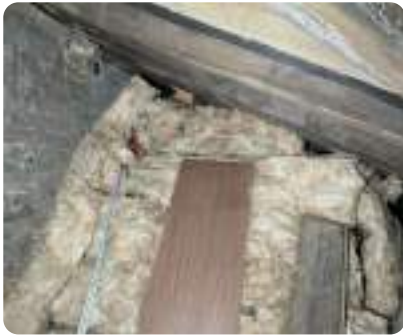
**Photo 106**  
Roof void with visible insulation and timber; no visible defects.

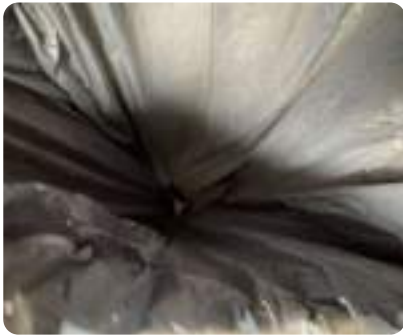
**Photo 109**  
Roof void within the property showing plastic sheeting; no visible defects.

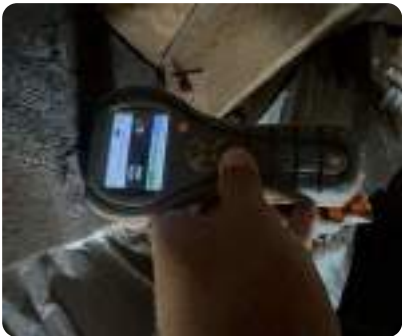
**Photo 111**  
Roof void showing moisture meter reading of 8.7 on the wooden beam. No visible defects.

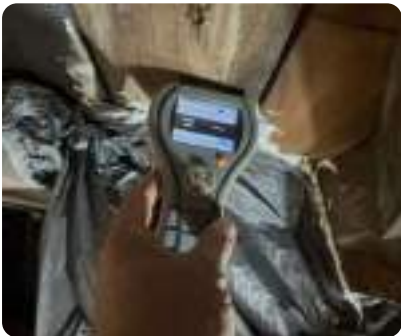
**Photo 113**  
Roof void area showing moisture meter in use; no visible defects.

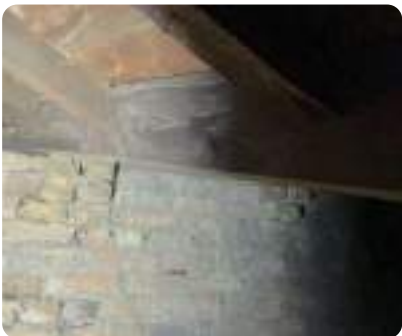
**Photo 117**  
High Moisture Readings and Locations

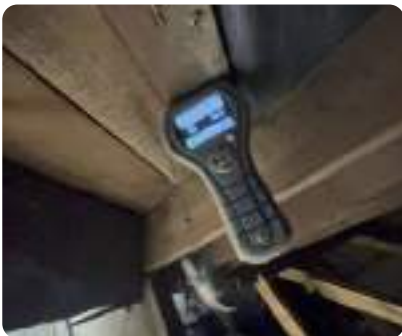
**Photo 118**  
High Moisture Readings and Locations

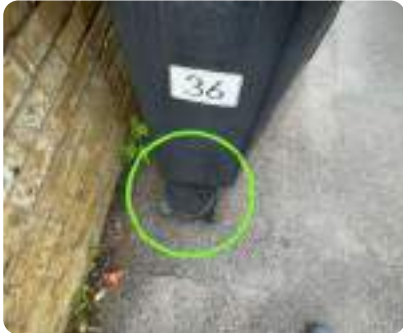
Photo 134  
Water meter valve box.

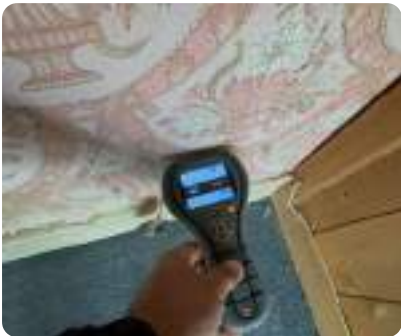
**Photo 223**  
Bedroom 3 - Wall behind the bath in  
bedroom 3

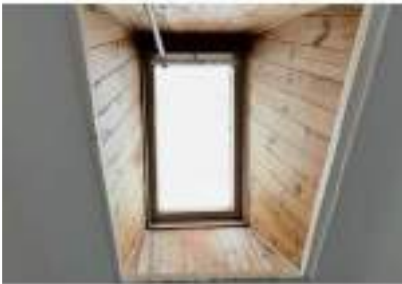
Photo 315  
Hallway - Velux window no evidence of active leaks.
