# Building Survey

36 HAVELOCK ROAD  
LONDON  
SE9 2DS

DB-SE42DQ-36

11 June 2026

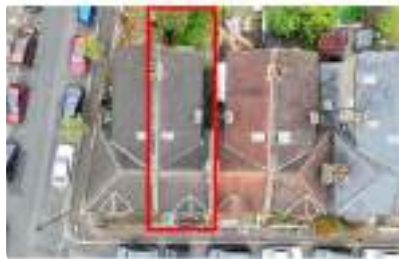
**Photo 2**  
Main roof viewed from above

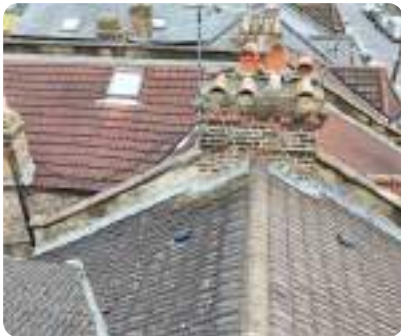
**Photo 8**  
Chimney stack on the rear elevation; no visible defects.

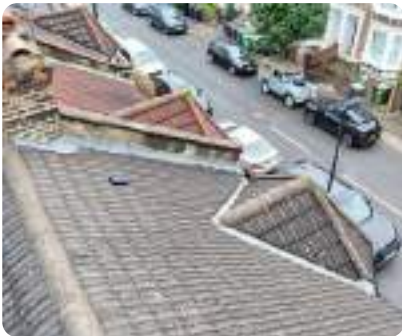
**Photo 9**  
Main roof concrete interlocking tiles generally appear to be in an adequate condition but spalling render on valleys requires repair.

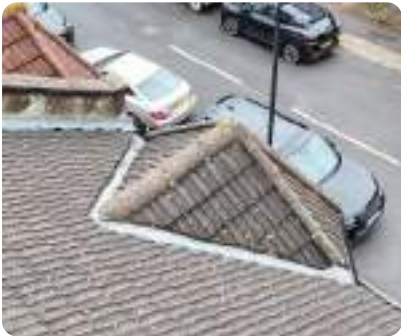
**Photo 10**  
Main roof concrete interlocking tiles generally appear to be in an adequate condition but spalling render on valleys requires repair.

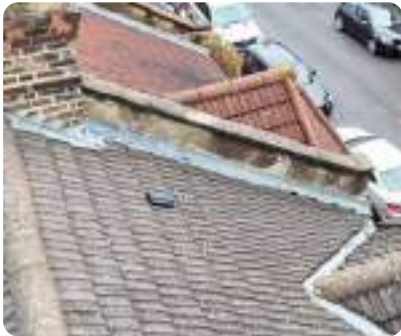
**Photo 11**  
Main roof concrete interlocking tiles generally appear to be in an adequate condition but spalling render on valleys requires repair.

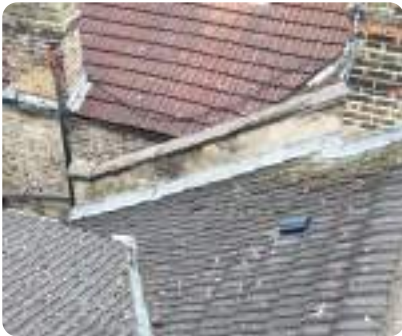
**Photo 12**  
Main roof concrete interlocking tiles generally appear to be in an adequate condition but spalling render on valleys requires repair.

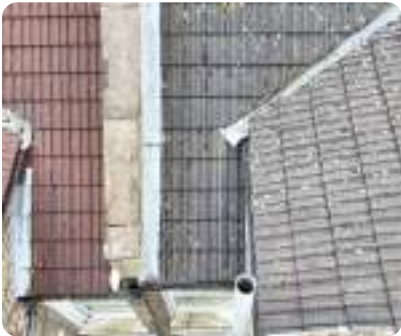
**Photo 16**  
Main roof concrete interlocking tiles  
generally appear to be in an adequate  
condition but spalling render on valleys  
requires repair.

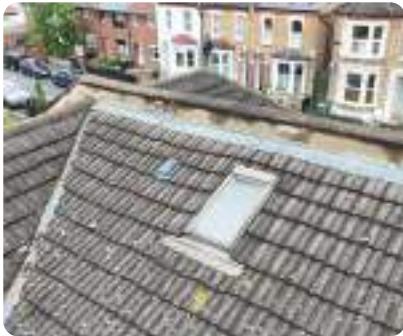
**Photo 18**  
Main roof concrete interlocking tiles  
generally appear to be in an adequate  
condition but spalling render on valleys  
requires repair.

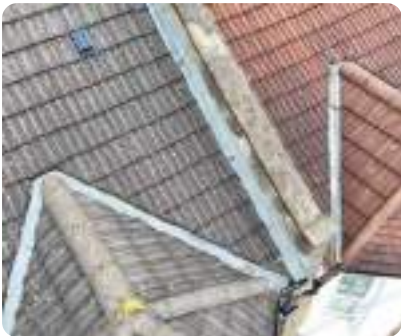
**Photo 25**  
Main roof concrete interlocking tiles generally appear to be in an adequate condition but spalling render on valleys requires repair.

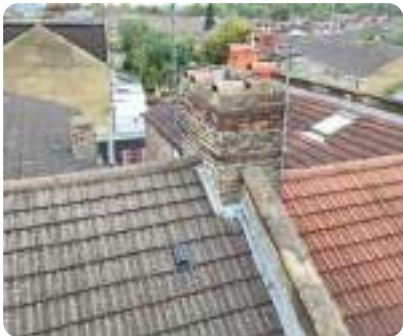
**Photo 26**  
Main roof concrete interlocking tiles generally appear to be in an adequate condition but spalling render on valleys requires repair.

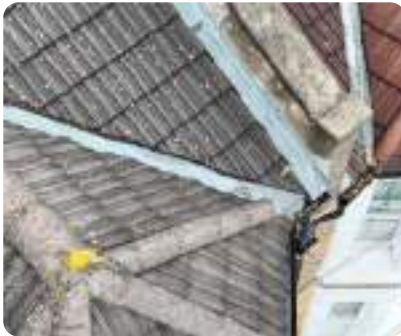
**Photo 30**  
Main roof concrete interlocking tiles generally appear to be in an adequate condition but spalling render on valleys requires repair.

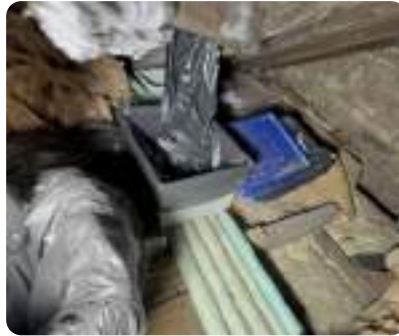
**Photo 93**  
Roof void observed with stored items and insulation material; no visible defects.

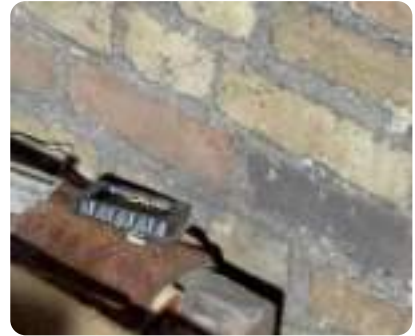
**Photo 94**  
Roof void visible near brickwork; no visible defects.

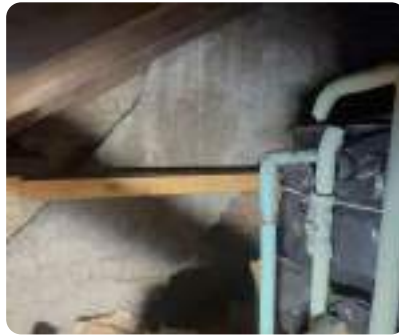
**Photo 96**  
Roof void showing exposed timber rafters and plumbing pipes; no visible defects.

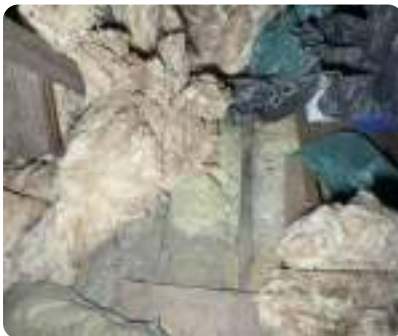
**Photo 98**  
Roof void showcasing insulation material and cluttered items; no visible defects.

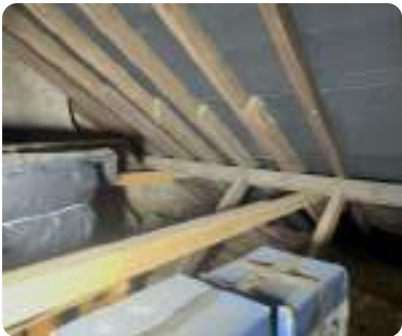
**Photo 102**  
Roof void showing timber rafters and insulation; no visible defects.

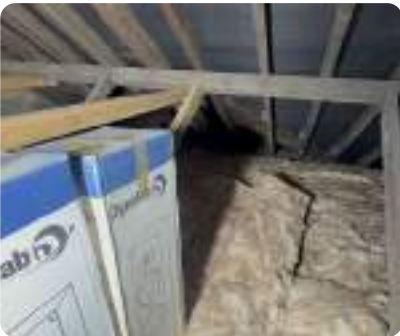
**Photo 103**  
Roof void observed with exposed timber rafters and insulation; no visible defects.

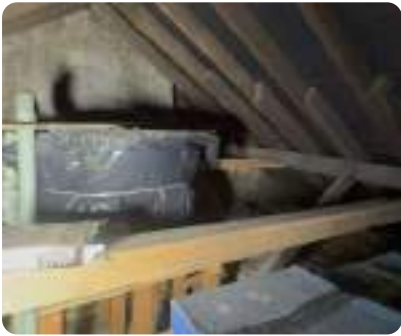
**Photo 104**  
Loft space containing storage boxes and visible pipework; no visible defects.

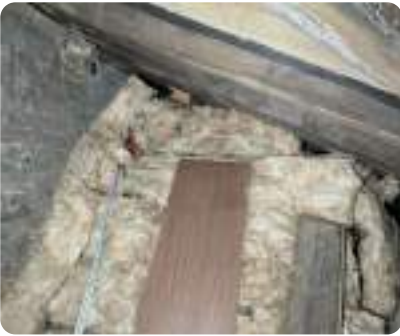
**Photo 106**  
Roof void with visible insulation and timber; no visible defects.

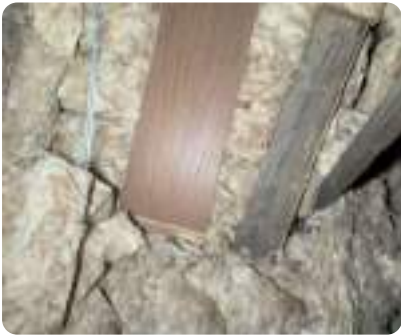
**Photo 107**  
Roof void showing insulation material and wooden beams; no visible defects.

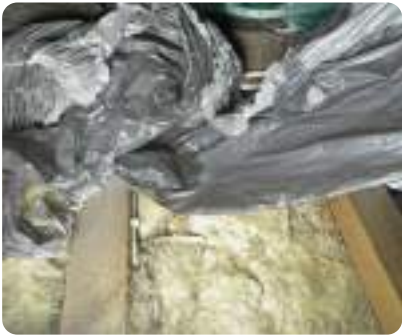
**Photo 108**  
Roof void with debris and plastic sheeting; no visible defects.

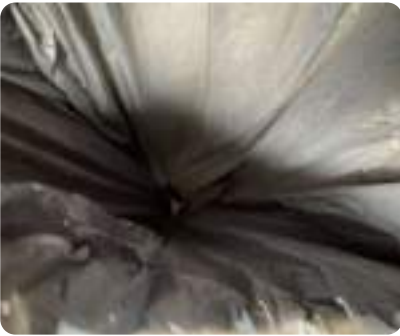
**Photo 109**  
Roof void within the property showing plastic sheeting; no visible defects.

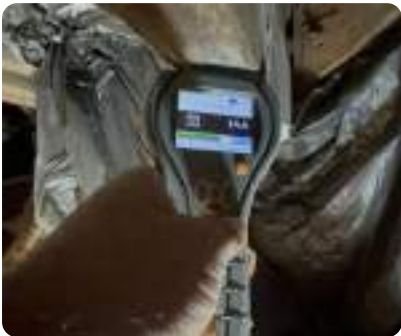
**Photo 110**  
Roof void showing moisture meter reading of 14.4; no visible defects.

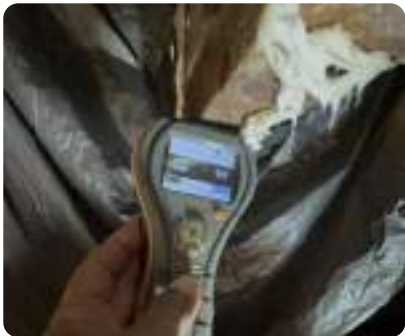
**Photo 115**  
Roof void showing moisture meter reading of 9.5%, indicating potential moisture presence.

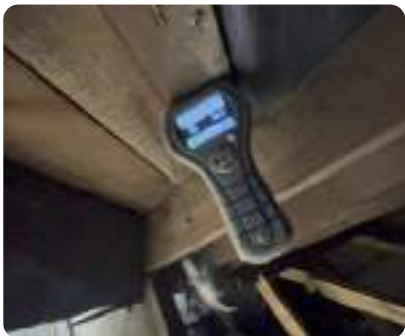
**Photo 118**  
High Moisture Readings and Locations

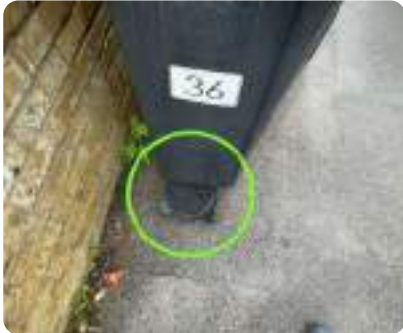
Photo 134  
Water meter valve box.

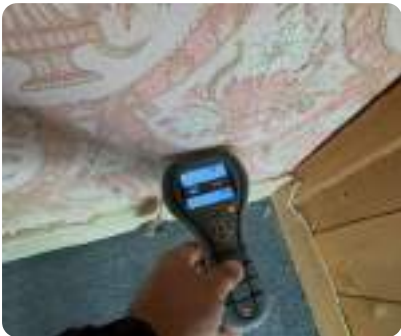
**Photo 223**  
Bedroom 3 - Wall behind the bath in  
bedroom 3
