# Building Survey

36 HAVELOCK ROAD  
LONDON  
SE9 2DS

DB-SE42DQ-36

11 June 2026

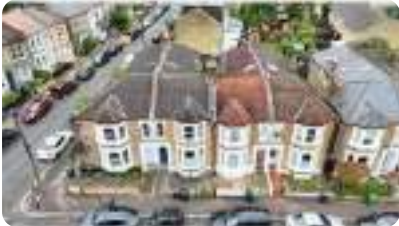
The main roof covering is in generally adequate condition for its age, with no significant defects visible from the available vantage points. The principal concerns are the history of water ingress suggested by containers in the roof void, the elevated moisture reading on the valley rafter, and the inherent risk of thermal loosening at the straight-cut lead flashings to the front parapets. A competent roofer must be commissioned to repair spalling filleting render on the parapets, confirm the integrity of the flashings and to identify any concealed defects before exchange of contracts. Failure to undertake these repairs could lead to rot to the valley rafter, worsening of leaks, collapsed ceilings and higher repair costs.

You could ask the vendor to undertake these repairs or use this as a negotiation point.

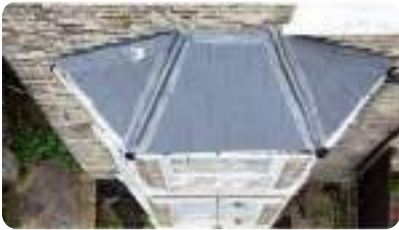
The rear bay roof is in adequate condition for its relatively modern age, with no significant defects identified. The main risk is the potential for concealed deterioration at the abutments and leadwork, although no evidence of this was found. Routine maintenance and periodic inspection, particularly after severe weather, will help to ensure the roof continues to perform adequately. No immediate repairs are required. The downpipe is not routed in to an underground drainage system or soak away, but this is a very small area or roof to warrant such measure on this old building. You could potentially route the downpipe into the combine surface water gulley on the rear corner to the left of the bay.

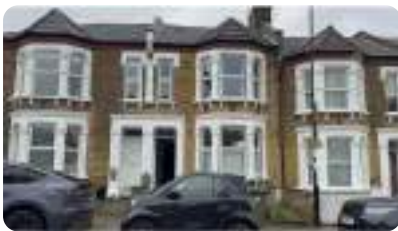
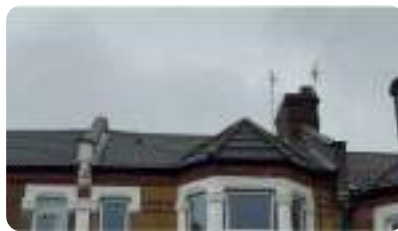
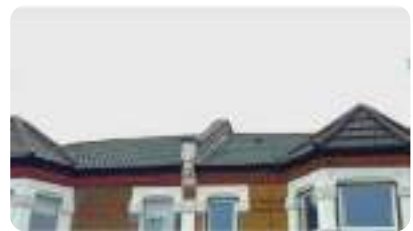
Any future insulation or render works must be carefully designed to avoid trapping moisture. The parapet repair should be undertaken promptly to prevent water ingress, and the damp-proof course bridging should be addressed to reduce moisture levels in the front wall.

You could ask the vendor to undertake these repairs or use this as a negotiation point.

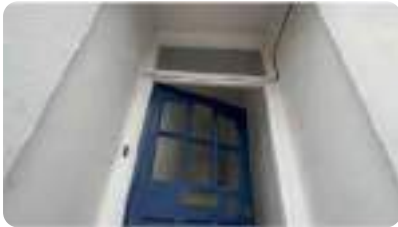
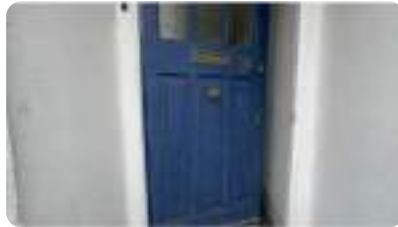
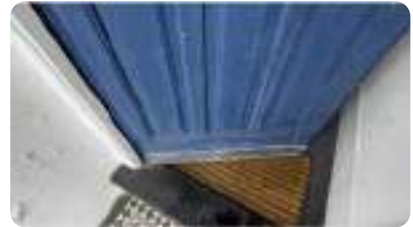
The external doors present a mixed picture. The rear uPVC door is in adequate condition and provides a reasonable standard of security and thermal performance. The front entrance door is the main concern. It is an older, single-glazed timber door that requires redecoration and is thermally inefficient. Its basic locking arrangement offers a lower level of security compared to a modern door. The most significant implications are ongoing heat loss and higher energy bills, alongside a potential security weakness. You should budget for the replacement of the front door with a modern, insulated unit, which would improve both energy efficiency and security. In the short term, redecoration is needed to protect the existing timber from deterioration.

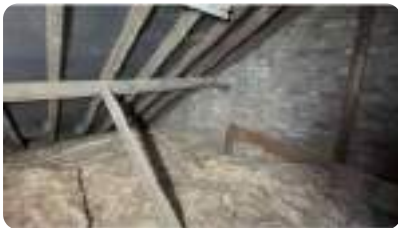
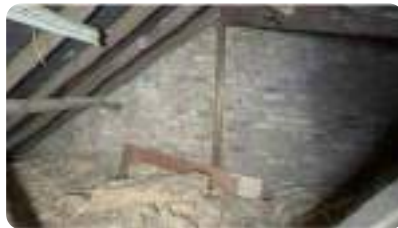
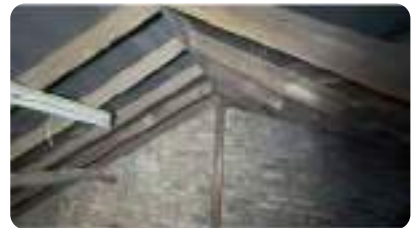
The visible roof structure is in serviceable condition, with no evidence of active decay or significant distortion. The retrofitted collars are a positive feature. The principal concerns are the evidence of historic water ingress, the sporadic and inadequate insulation, and the presence of pest control measures. The source of the past leakage should be investigated by a roofer, as intermittent defects can be difficult to identify during dry weather. The insulation should be improved and laid to a consistent depth, taking care not to block eaves ventilation. The pest control measures suggest a need for ongoing monitoring, and the wasps' nest, though inactive, should be removed. The EPC description of the roof insulation is not consistent with the visible evidence, and the client should not rely on the EPC alone when assessing thermal performance.

You could ask the vendor to undertake remedial work or use this as a negotiation point as dampness is a material defect.

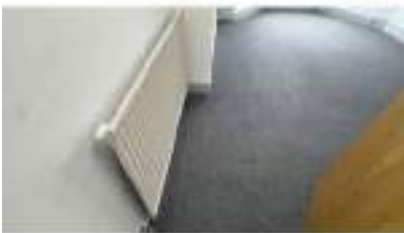
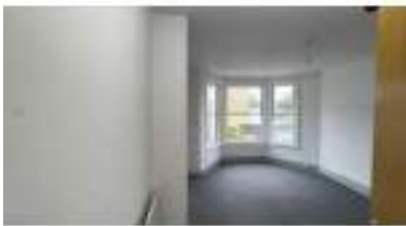
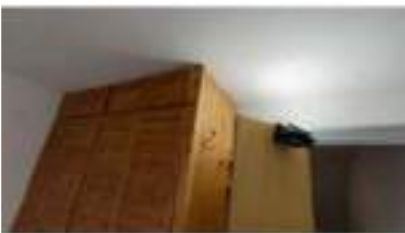
Bedroom 3

- The chimney breast has been blocked up and no ventilation has been provided, which increases the risk of condensation and dampness within the flue; a vent should be installed

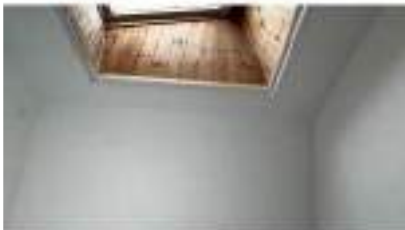
Hallway - Velux window no evidence of active leaks.

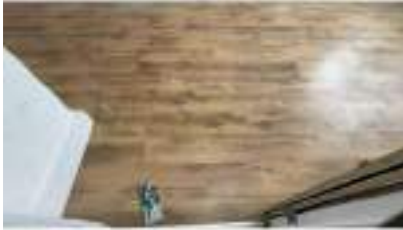
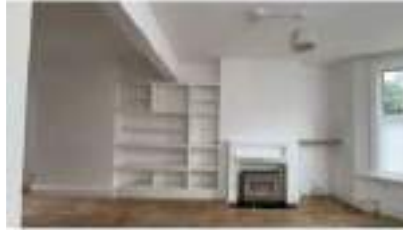
Reception room

- There are two chimney breasts. The front chimney breast contains a gas fire. The rear chimney breast has been blocked up. The gas fire should be serviced and its safety checked by a Gas Safe registered engineer before use, as its service history is unknown. The ventilation provision for the blocked-up chimney breast should be checked to ensure it is adequate to prevent dampness

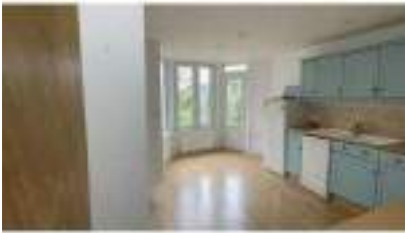
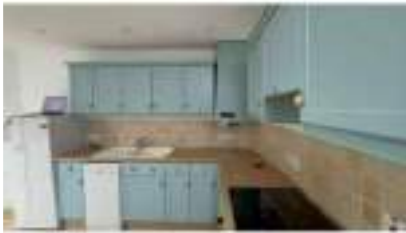
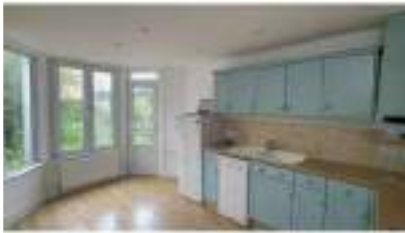
Kitchen

- The kitchen units are of 1980s laminated chipboard construction, well over 20 years old, and are in poor condition; complete stripping out and replacement is required as the units are beyond economic repair

- Plasterboard ceilings are present with inset LED spotlights that were working at the time of inspection but are poorly fitted and poorly positioned, resulting in an unsatisfactory lighting layout; the entire lighting arrangement would benefit from redesign and replacement as part of future kitchen refurbishment

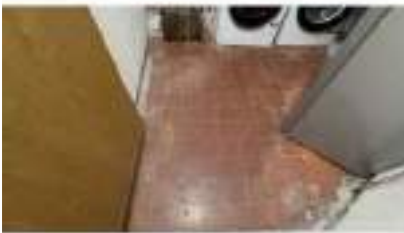
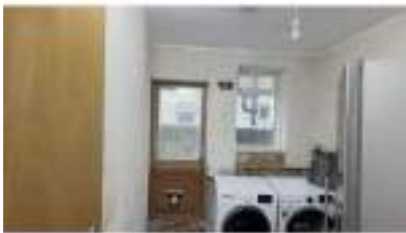
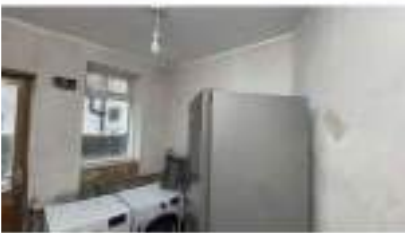
Utility Room

- The stone step at the utility room entrance is old but appears to be in adequate condition
- The gully appeared to be in adequate condition but would benefit from cleaning and a cover to prevent debris entering the drain

- The soil stack at the rear of the property is a mix of cast iron to the upper section and UPVC to the base, suggesting past drainage repairs; your Legal Adviser should check the property information for any evidence of underpinning or a claim for defective drainage-related subsidence

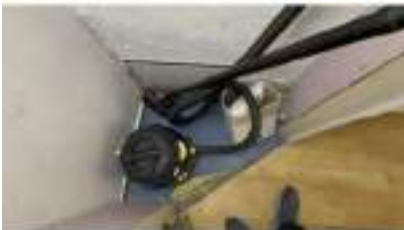
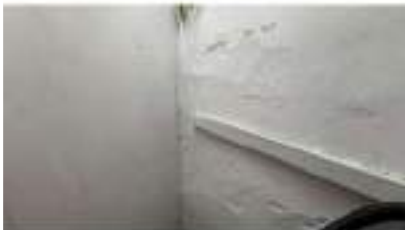
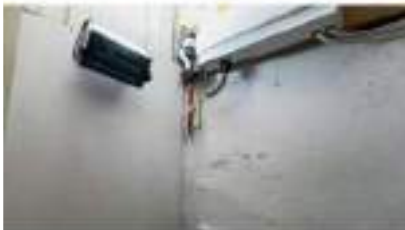
Hallway

- A breach in the fire boarding was noted at the staircase, which should be repaired to restore the integrity of the fire separation

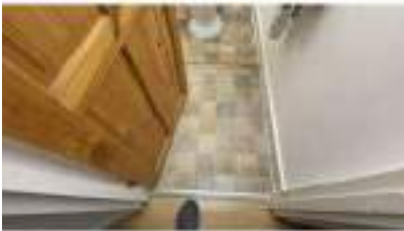
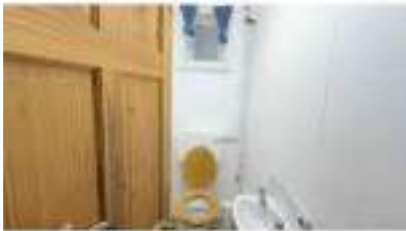
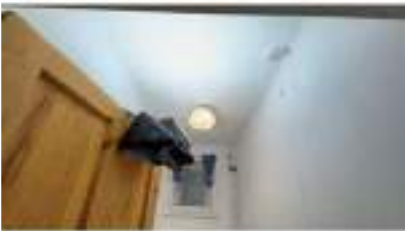
WC Ground Floor

- The ceiling is plastered and painted. from ground level
- The light fitting is a standard pendant set
- The walls are plastered and painted
- The room contains a low-level WC and a wall-hung wash hand basin. The sanitaryware is of an older style but appeared functional. No significant leaks or defects were identified during the inspection
- The floor covering is vinyl
- The window is a single-glazed timber-framed unit. The paint finish is peeling and redecoration is needed. The window is of an older style and an upgrade to a modern double-glazed unit would improve thermal performance
- The door is a traditional timber panelled door. The paint finish is peeling and redecoration is needed
- There is no heating source in this room

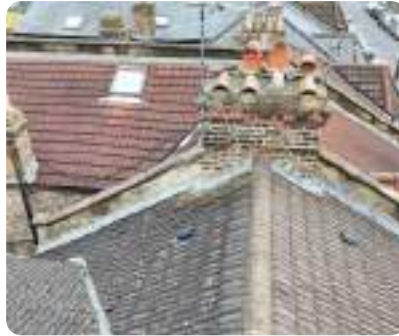
**Photo 8**

Chimney stack on the rear elevation; no visible defects.

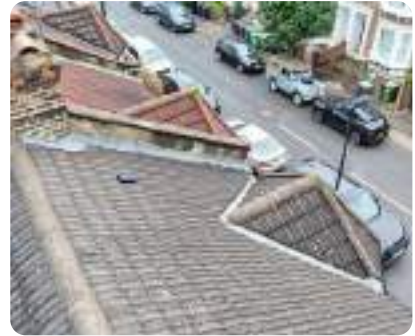
**Photo 9**

Main roof concrete interlocking tiles generally appear to be in an adequate condition but spalling render on valleys requires repair.

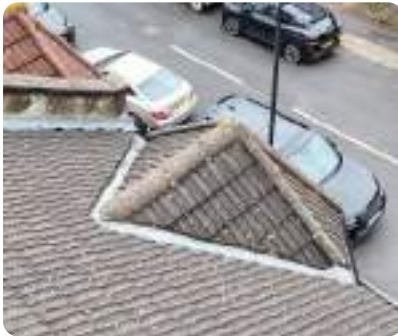
**Photo 10**

Main roof concrete interlocking tiles generally appear to be in an adequate condition but spalling render on valleys requires repair.

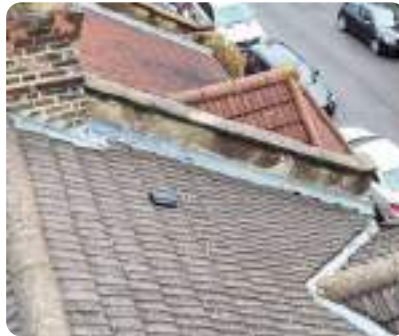
**Photo 11**

Main roof concrete interlocking tiles generally appear to be in an adequate condition but spalling render on valleys requires repair.

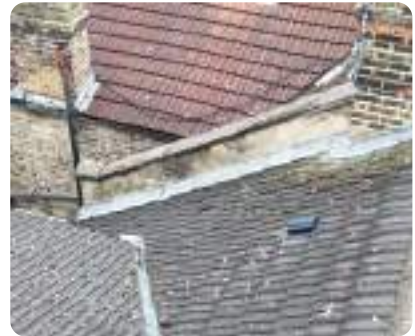
**Photo 12**

Main roof concrete interlocking tiles generally appear to be in an adequate condition but spalling render on valleys requires repair.

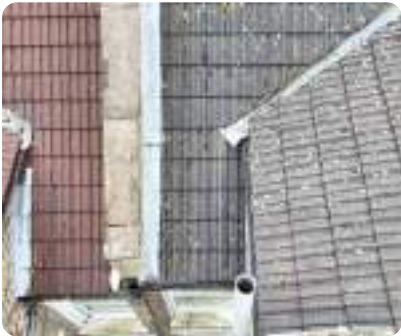
**Photo 16**  
Main roof concrete interlocking tiles  
generally appear to be in an adequate  
condition but spalling render on valleys  
requires repair.

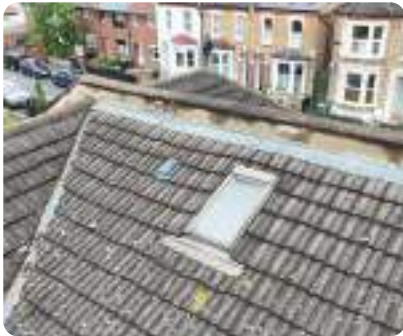
**Photo 18**  
Main roof concrete interlocking tiles  
generally appear to be in an adequate  
condition but spalling render on valleys  
requires repair.

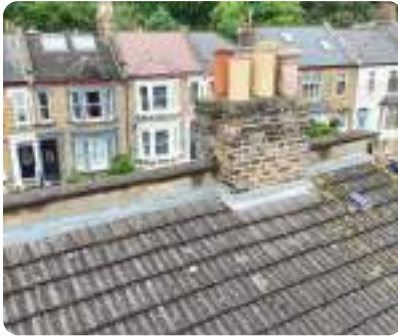
**Photo 19**

Chimney stack on the rear elevation; no visible defects.

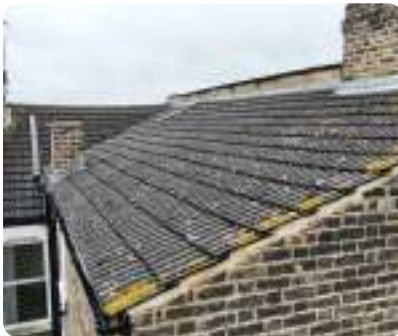
**Photo 22**

Main roof concrete interlocking tiles generally appear to be in an adequate condition but spalling render on valleys requires repair.

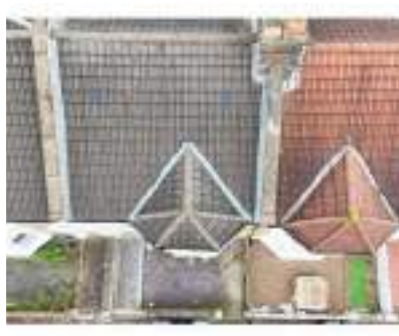
**Photo 23**

Main roof concrete interlocking tiles generally appear to be in an adequate condition but spalling render on valleys requires repair.

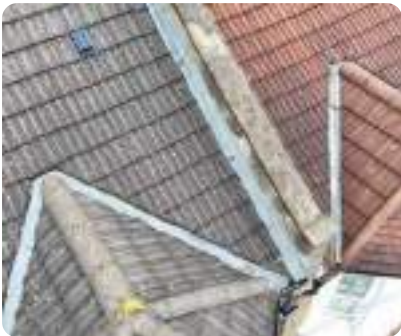
**Photo 25**  
Main roof concrete interlocking tiles generally appear to be in an adequate condition but spalling render on valleys requires repair.

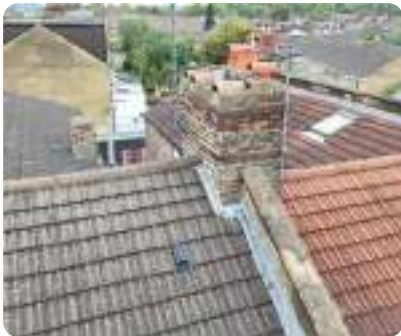
**Photo 26**  
Main roof concrete interlocking tiles generally appear to be in an adequate condition but spalling render on valleys requires repair.

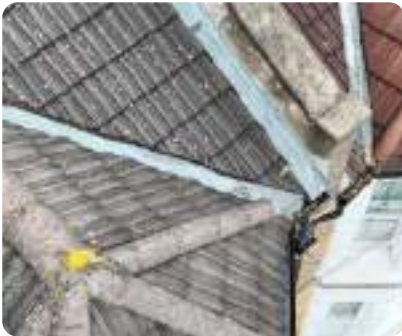
**Photo 30**  
Main roof concrete interlocking tiles generally appear to be in an adequate condition but spalling render on valleys requires repair.

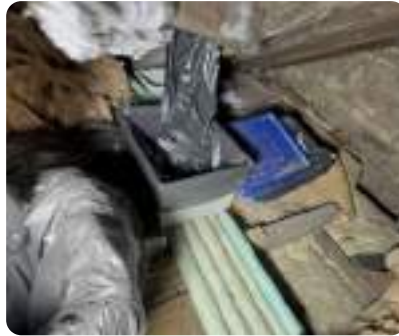
**Photo 93**  
Roof void observed with stored items and insulation material; no visible defects.

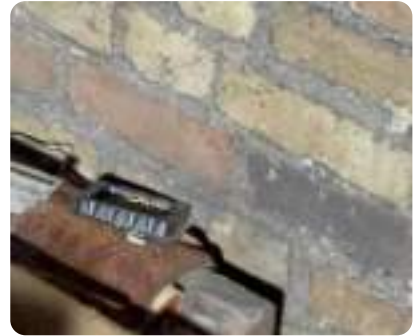
**Photo 94**  
Roof void visible near brickwork; no visible defects.

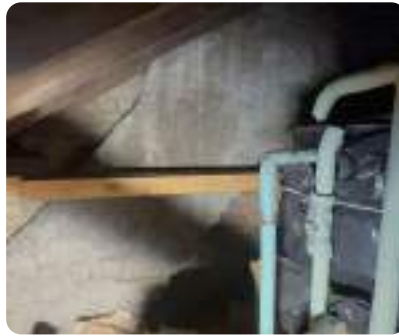
**Photo 96**  
Roof void showing exposed timber rafters and plumbing pipes; no visible defects.

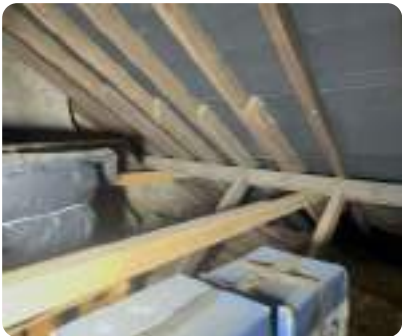
**Photo 102**  
Roof void showing timber rafters and insulation; no visible defects.

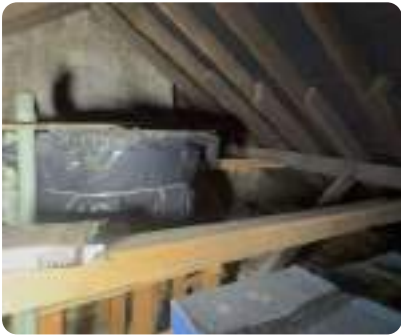
**Photo 104**  
Loft space containing storage boxes and visible pipework; no visible defects.

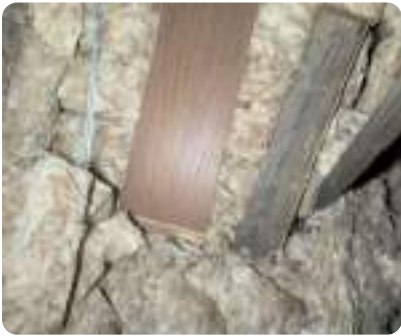
**Photo 107**  
Roof void showing insulation material and wooden beams; no visible defects.

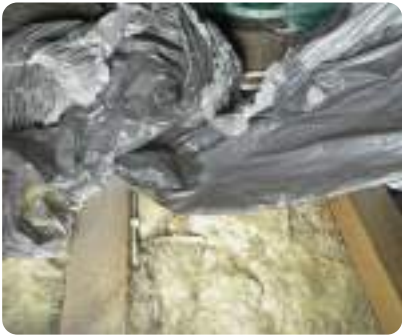
**Photo 108**  
Roof void with debris and plastic sheeting; no visible defects.

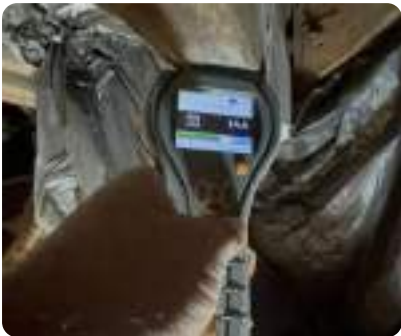
**Photo 110**  
Roof void showing moisture meter reading of 14.4; no visible defects.
