# Building Survey

36 HAVELOCK ROAD  
LONDON  
SE9 2DS

DB-SE42DQ-36

11 June 2026

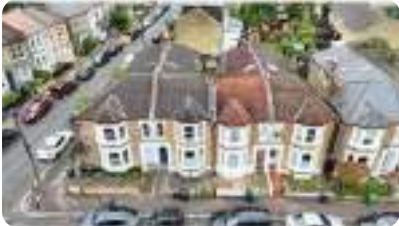
The main roof covering is in generally adequate condition for its age, with no significant defects visible from the available vantage points. The principal concerns are the history of water ingress suggested by containers in the roof void, the elevated moisture reading on the valley rafter, and the inherent risk of thermal loosening at the straight-cut lead flashings to the front parapets. A competent roofer must be commissioned to repair spalling filleting render on the parapets, confirm the integrity of the flashings and to identify any concealed defects before exchange of contracts. Failure to undertake these repairs could lead to rot to the valley rafter, worsening of leaks, collapsed ceilings and higher repair costs.

You could ask the vendor to undertake these repairs or use this as a negotiation point.

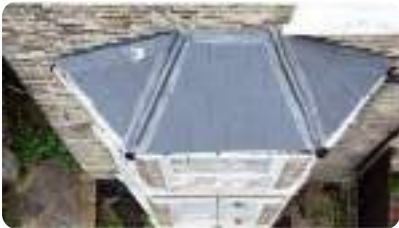
The rear bay roof is in adequate condition for its relatively modern age, with no significant defects identified. The main risk is the potential for concealed deterioration at the abutments and leadwork, although no evidence of this was found. Routine maintenance and periodic inspection, particularly after severe weather, will help to ensure the roof continues to perform adequately. No immediate repairs are required. The downpipe is not routed in to an underground drainage system or soak away, but this is a very small area or roof to warrant such measure on this old building. You could potentially route the downpipe into the combine surface water gulley on the rear corner to the left of the bay.

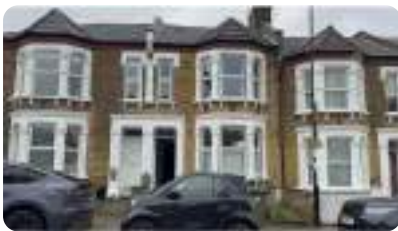
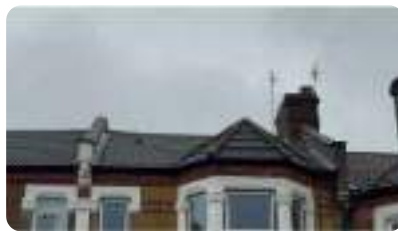
Any future insulation or render works must be carefully designed to avoid trapping moisture. The parapet repair should be undertaken promptly to prevent water ingress, and the damp-proof course bridging should be addressed to reduce moisture levels in the front wall.

You could ask the vendor to undertake these repairs or use this as a negotiation point.

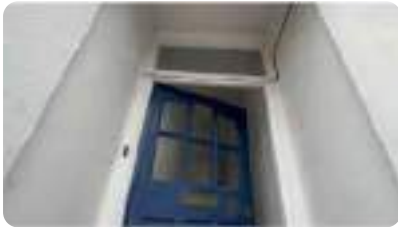
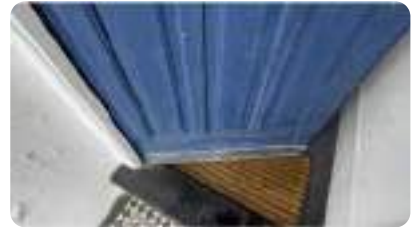
The external doors present a mixed picture. The rear uPVC door is in adequate condition and provides a reasonable standard of security and thermal performance. The front entrance door is the main concern. It is an older, single-glazed timber door that requires redecoration and is thermally inefficient. Its basic locking arrangement offers a lower level of security compared to a modern door. The most significant implications are ongoing heat loss and higher energy bills, alongside a potential security weakness. You should budget for the replacement of the front door with a modern, insulated unit, which would improve both energy efficiency and security. In the short term, redecoration is needed to protect the existing timber from deterioration.

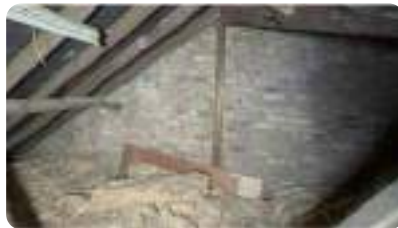
The visible roof structure is in serviceable condition, with no evidence of active decay or significant distortion. The retrofitted collars are a positive feature. The principal concerns are the evidence of historic water ingress, the sporadic and inadequate insulation, and the presence of pest control measures. The source of the past leakage should be investigated by a roofer, as intermittent defects can be difficult to identify during dry weather. The insulation should be improved and laid to a consistent depth, taking care not to block eaves ventilation. The pest control measures suggest a need for ongoing monitoring, and the wasps' nest, though inactive, should be removed. The EPC description of the roof insulation is not consistent with the visible evidence, and the client should not rely on the EPC alone when assessing thermal performance.

You could ask the vendor to undertake remedial work or use this as a negotiation point as dampness is a material defect.

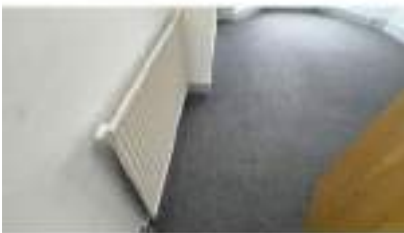
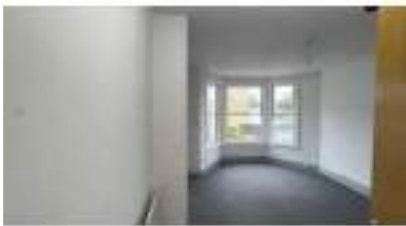
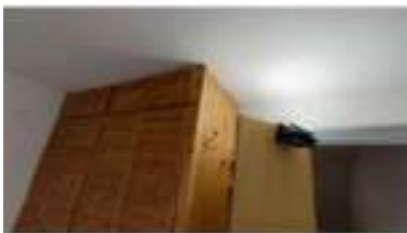
Bedroom 3

- The door is a notional fire door; its effectiveness as a fire door cannot be confirmed and upgrading to a certified fire door should be considered for safety

- The chimney breast has been blocked up and no ventilation has been provided, which increases the risk of condensation and dampness within the flue; a vent should be installed

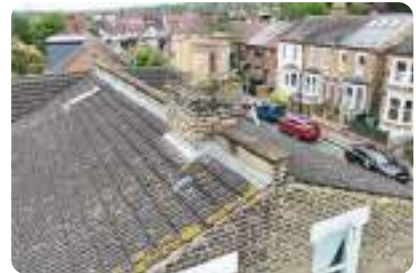
**Photo 3**  
Rear elevation main roof in clay tiles; no visible defects.

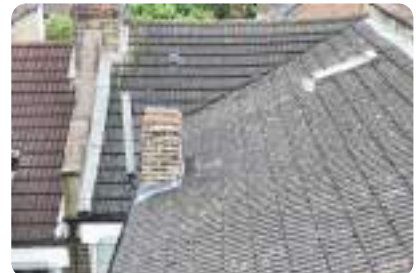
**Photo 6**  
Chimney stack on the main roof; no visible defects.

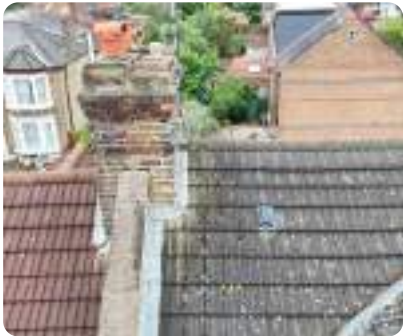
**Photo 17**  
Main roof concrete interlocking tiles  
generally appear to be in an adequate  
condition but spalling render on valleys  
requires repair.

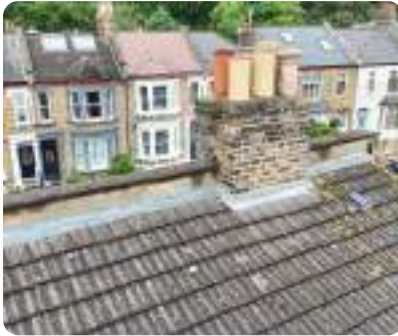
**Photo 19**

Chimney stack on the rear elevation; no visible defects.

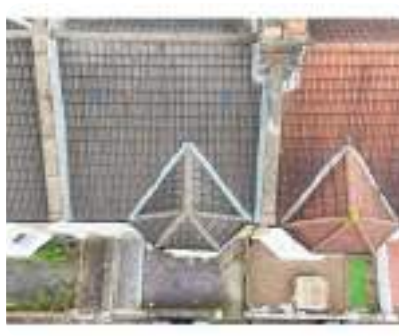
**Photo 23**

Main roof concrete interlocking tiles generally appear to be in an adequate condition but spalling render on valleys requires repair.

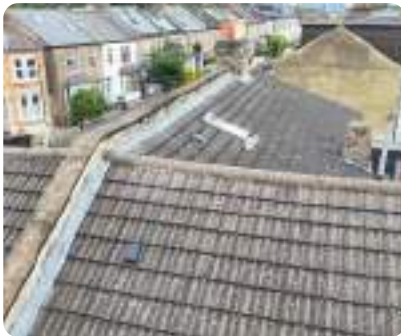
**Photo 27**  
Main roof concrete interlocking tiles generally appear to be in an adequate condition but spalling render on valleys requires repair.

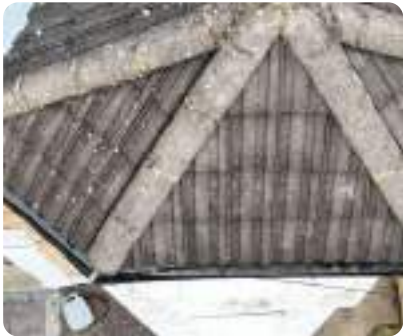
**Photo 29**  
Main roof concrete interlocking tiles generally appear to be in an adequate condition but spalling render on valleys requires repair.

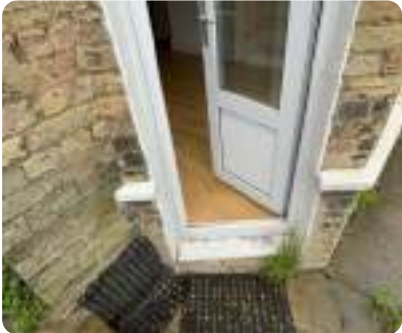
**Photo 72**  
External Walls - This rear bay has been structurally altered with a new door opening.

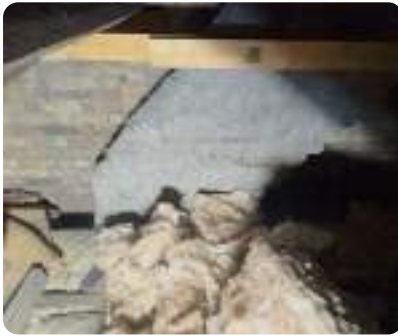
**Photo 95**  
Roof void showing insulation and exposed brickwork; no visible defects.

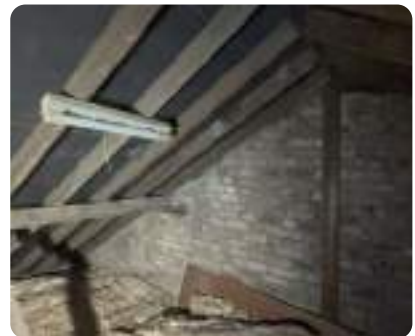
**Photo 100**  
Roof void showing timber framing and insulation; no visible defects.

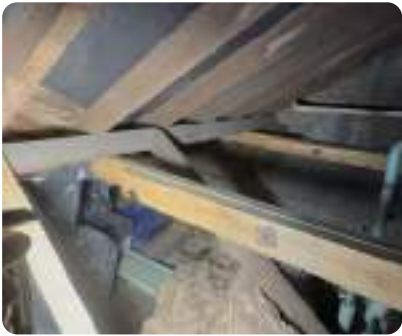
**Photo 105**  
Roof void showing timber framing and insulation materials; no visible defects.

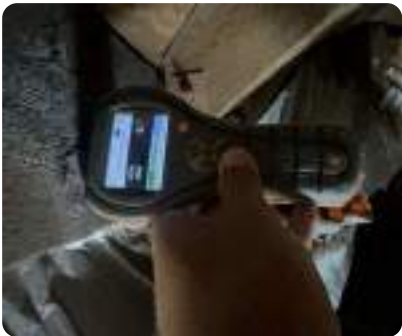
**Photo 111**  
Roof void showing moisture meter reading of 8.7 on the wooden beam. No visible defects.

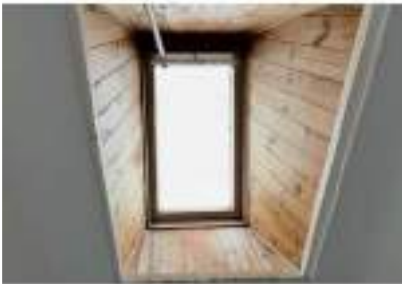
Photo 315  
Hallway - Velux window no evidence of active leaks.
